ACCIDENT INVESTIGATION REPORT
(UNDERGROUND COAL MINE)
NON-FATAL COAL OUTBURST ACCIDENT
NO. 37 MINE (I.D. NO. 15-04670)
ARCH OF KENTUCKY, INCORPORATED
CUMBERLAND, HARLAN COUNTY, KENTUCKY

JANUARY 11, 1991

REPORT OF INVESTIGATION
(UNDERGROUND COAL MINE)

NON-FATAL COAL OUTBURST ACCIDENT
NO. 37 MINE (I.D. NO. 15-04670)
ARCH OF KENTUCKY, INCORPORATED

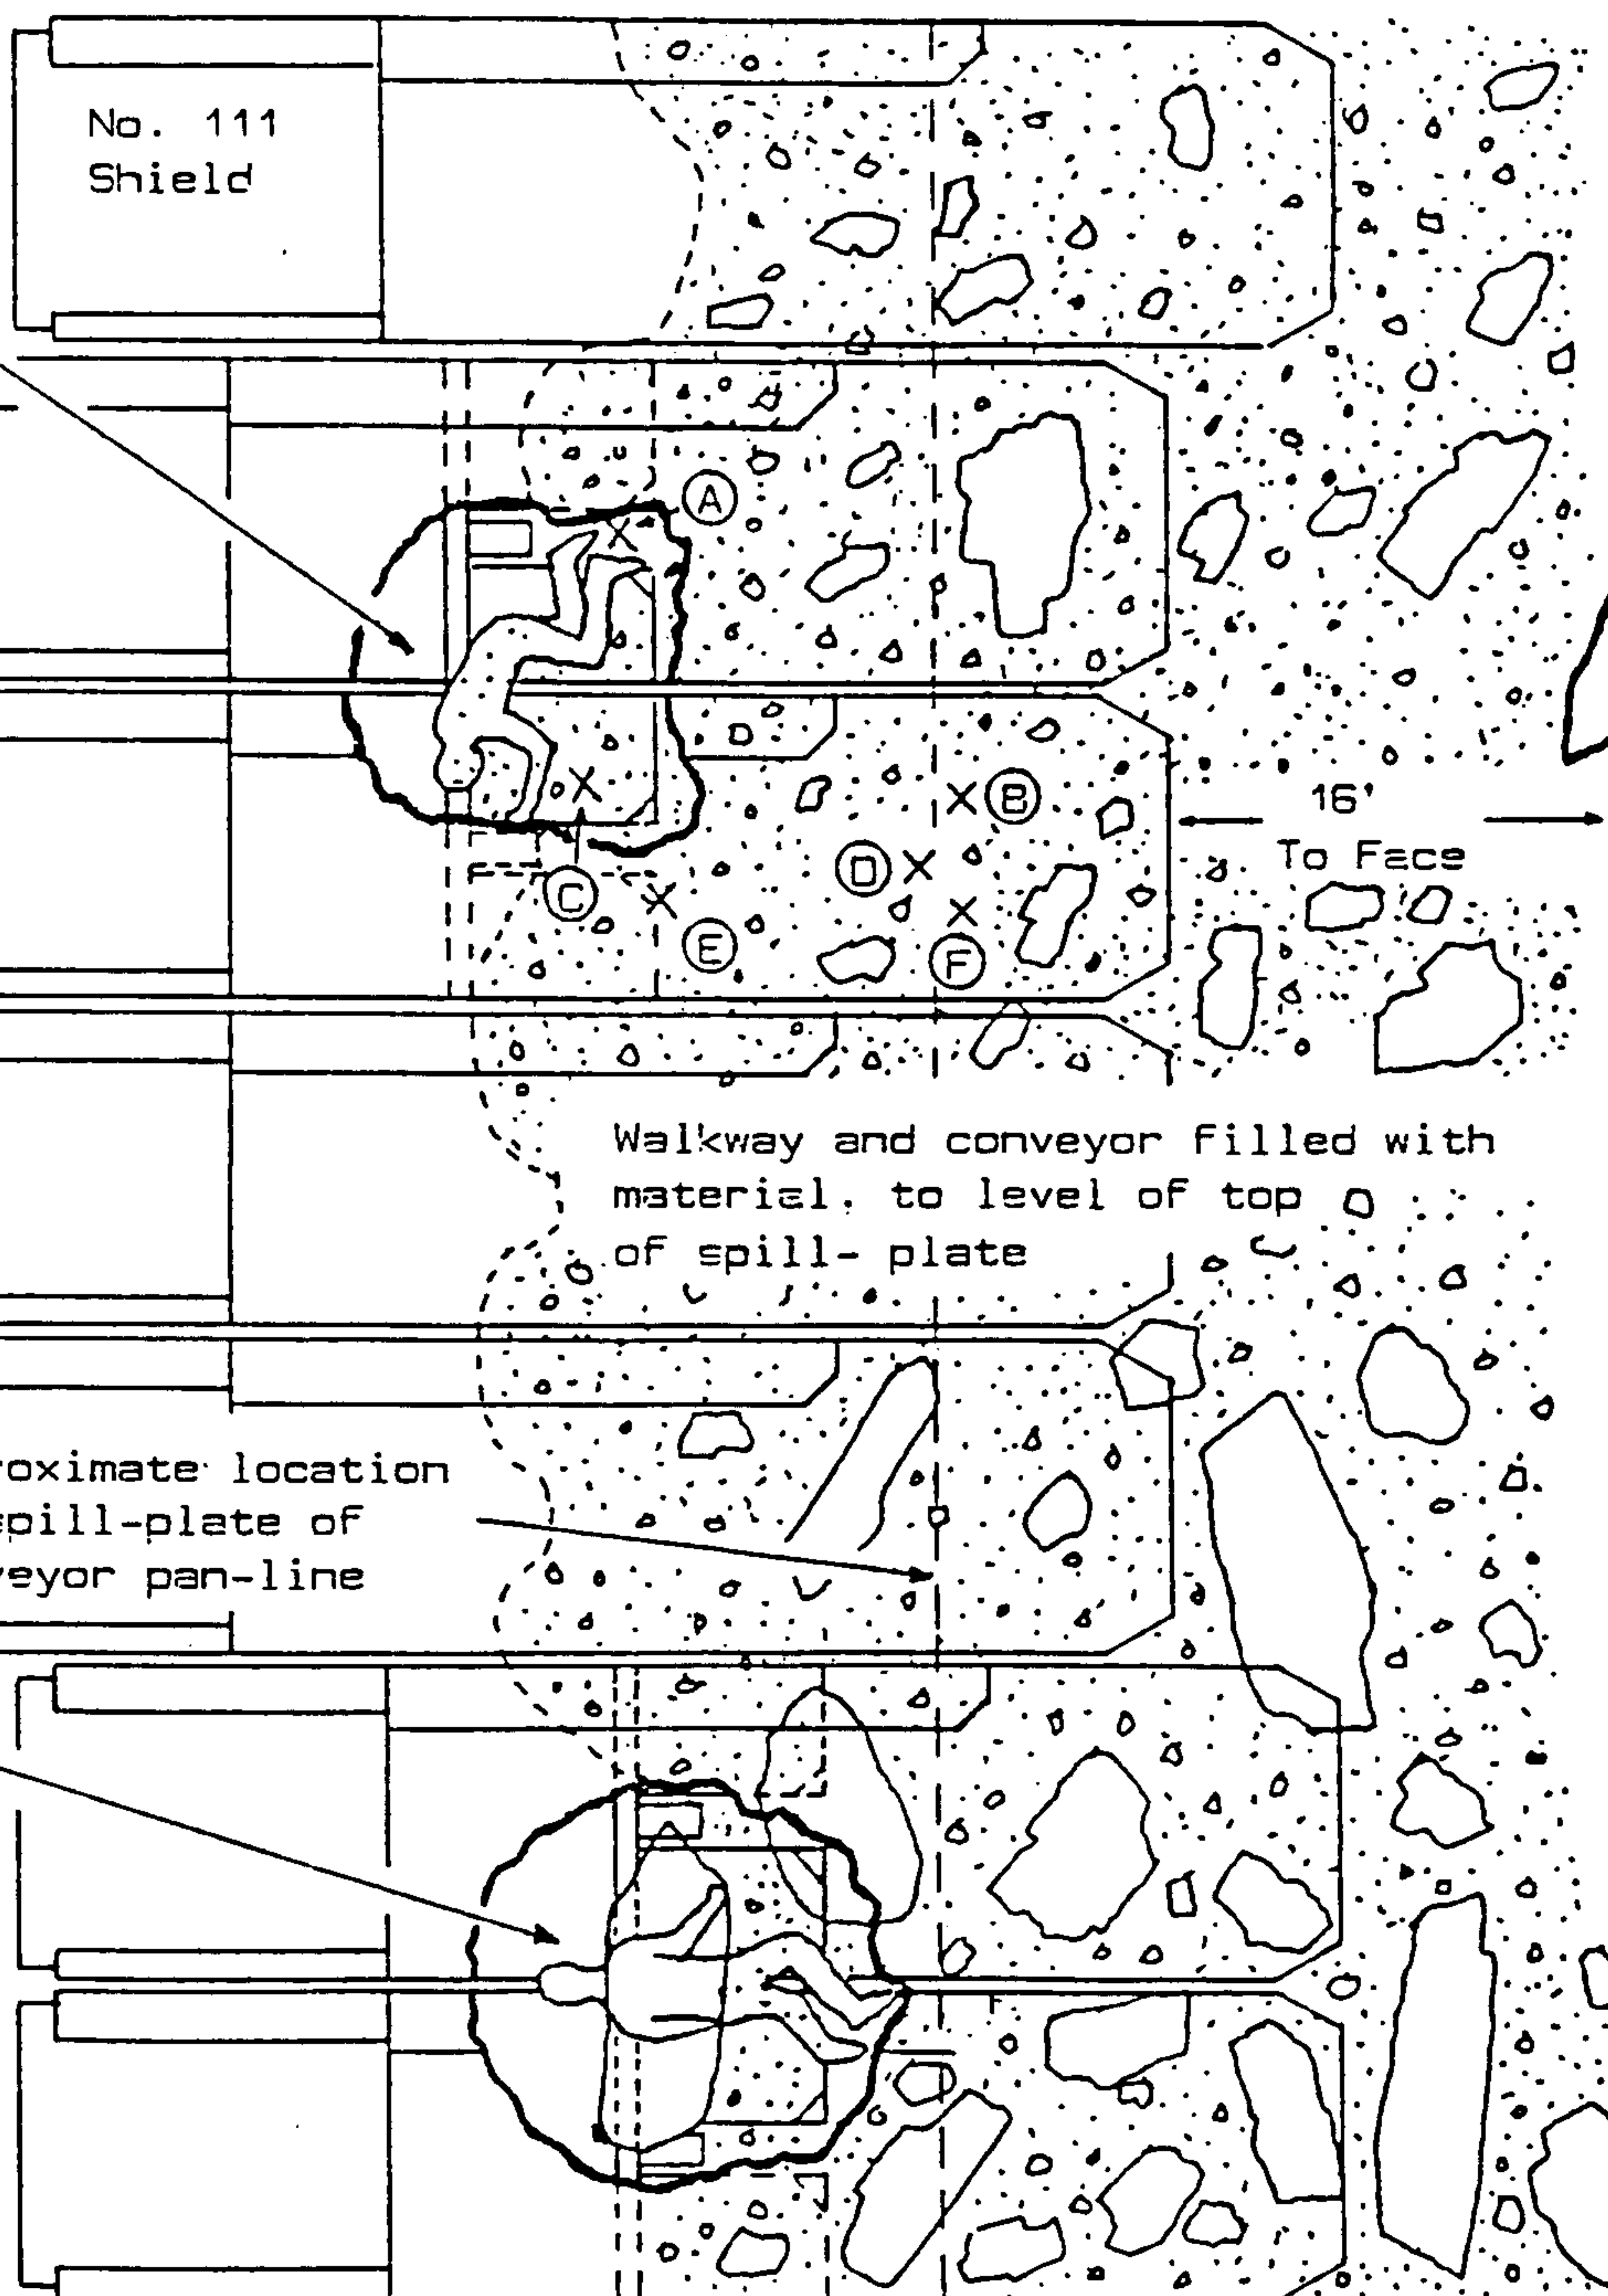
Drawing 3

Foutch was positioned at or near the No. 105 Shield when the outburst occurred. Foutch was also forced backward by the concussion and came to rest between the No. 105 and 106 Shields. Foutch was also covered by material and a piece of shale brow, which measured five (5) feet long, two (2) feet wide and sixteen and one-half (16 1/2) inches thick.

17. Approximately one-hundred fifty (150) U.S. tons of material was dislodged and/or expelled from the coal face. In addition, approximately twenty (20) U.S. tons of shale roof material was broken and expelled during the outburst. The material filled the walkway and the face conveyor pan-line, level with the conveyor pan spill place, and sloped upward to the mine roof. The area affected by this accumulation was from the Nos. 103 to 113 Shields. The face conveyor pan line was also filled with material from the Nos. 87 to 94 Shields.

Detailed View of Accident Site

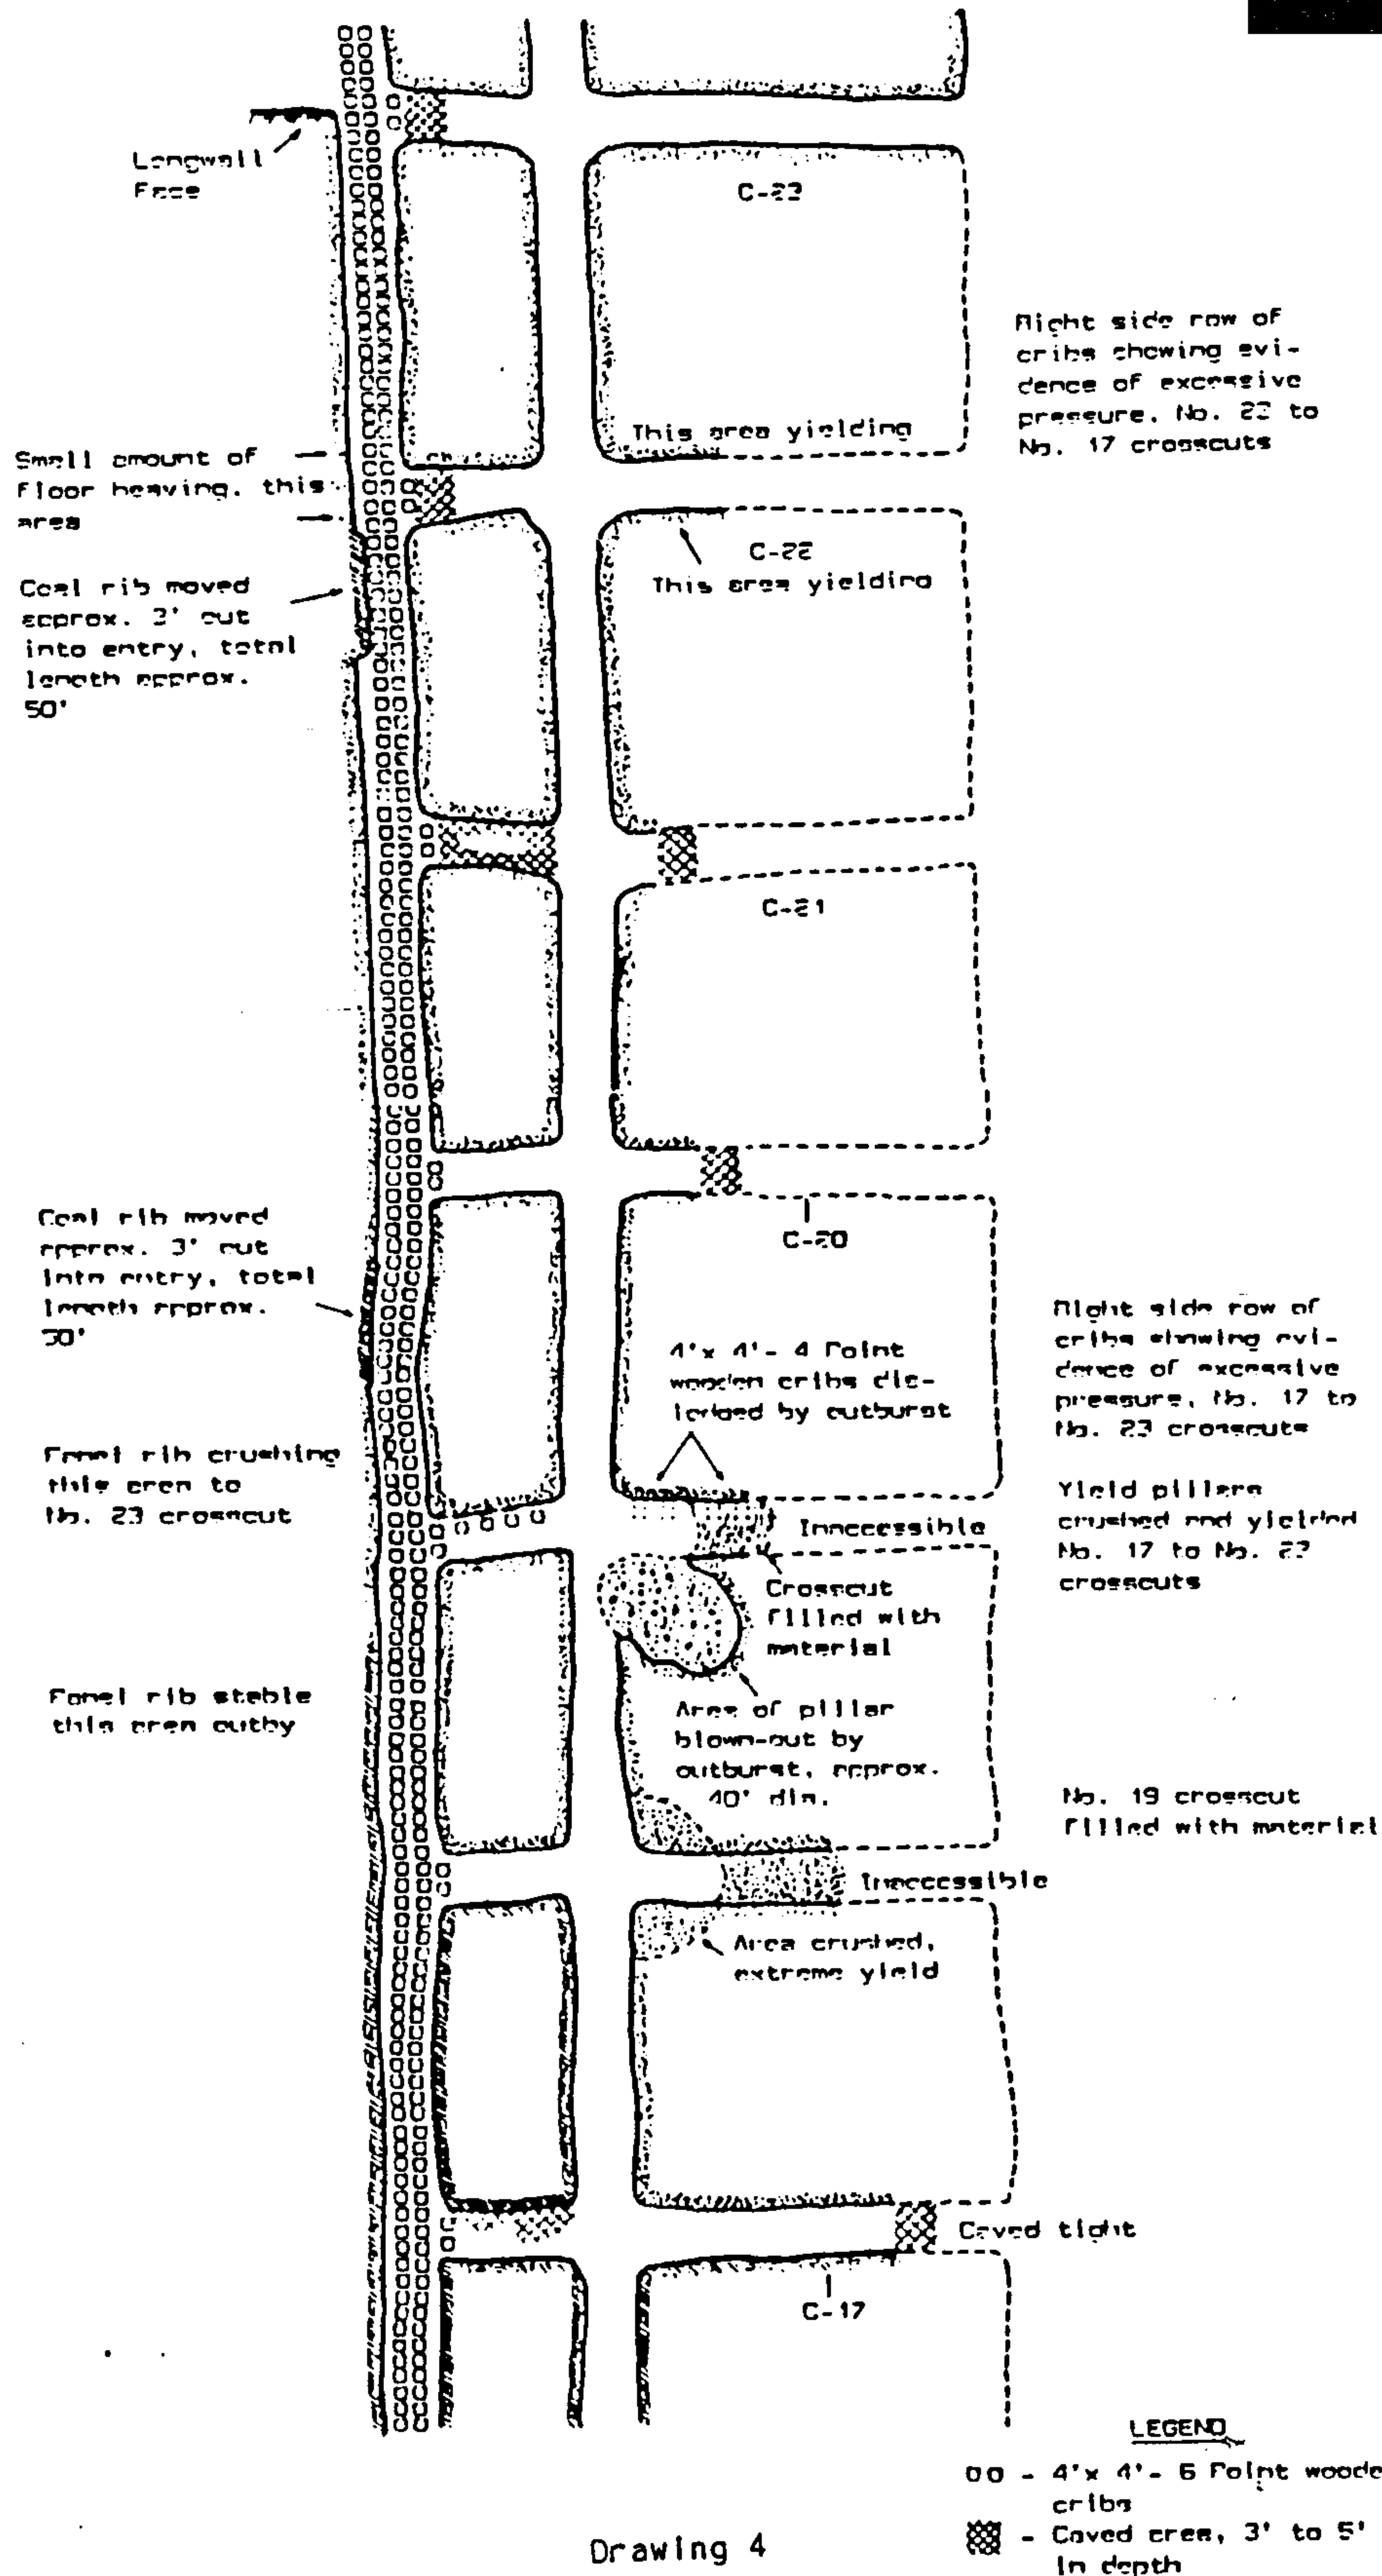
Drawing 4

20. An examination of the G-3 tailgate entries, outby the longwall face, was made during the investigation. The examination revealed indications of excessive pressure and lateral movement of the mine roof. The excessive abutment pressure resulted in the failure of the abutment pillar between the Nos. 19 and 20 crosscuts. (See Drawing 4)

The failure of the abutment pillar, between the Nos. 19 and 20 crosscuts, may have increased the abutment pressure.
